TEST REPORT

ST1046

LOAD TEST ON BATTEN AND CRADLE FLOOR

Batten and Cradle
Level 1,
20-22 Gundry Street
New Zealand

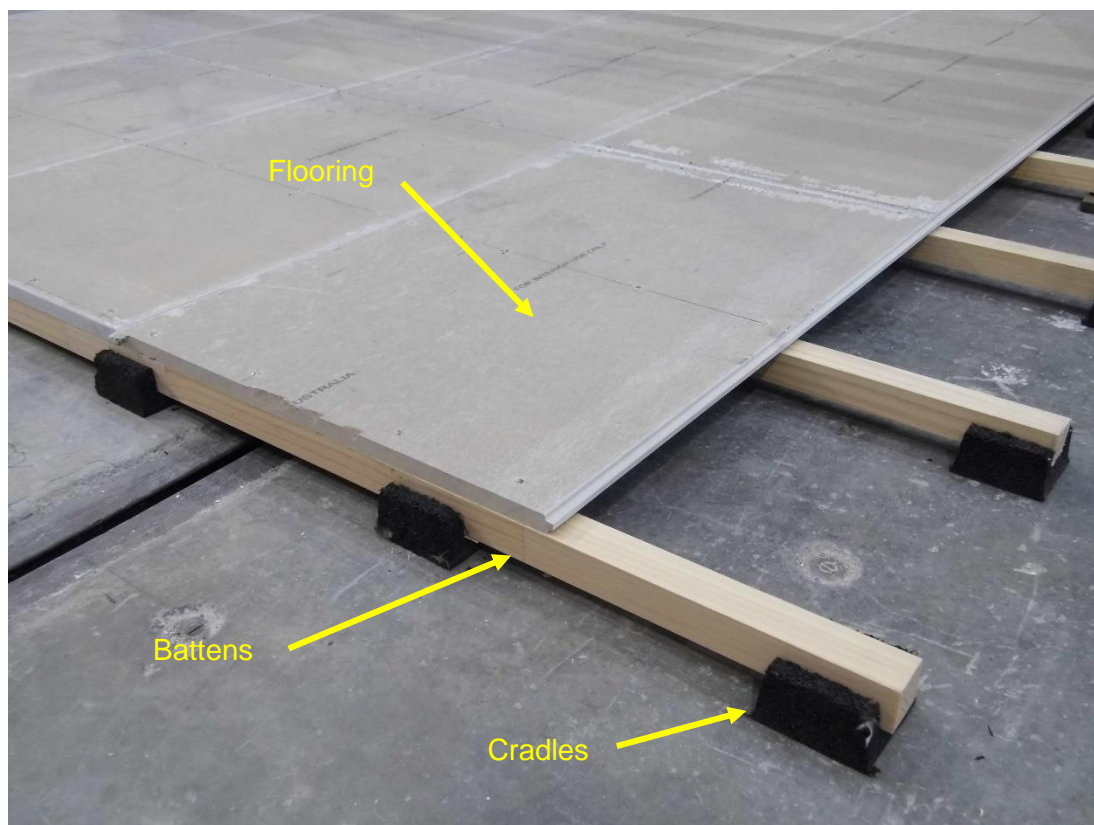
The Batten and Cradle flooring system is a proprietary flooring system utilising recycled rubber cradles laid on a concrete floor slab. Timber battens are placed in the cradles and flooring sheets are fixed to the battens to provide a substrate for various finishes. The flooring system combined with the base slab has favourable acoustic properties, and is intended for use in situations requiring acoustic separation. Photograph 1 shows the main features of the system.

Photograph 1. Main features of Batten and Cradle Floor System

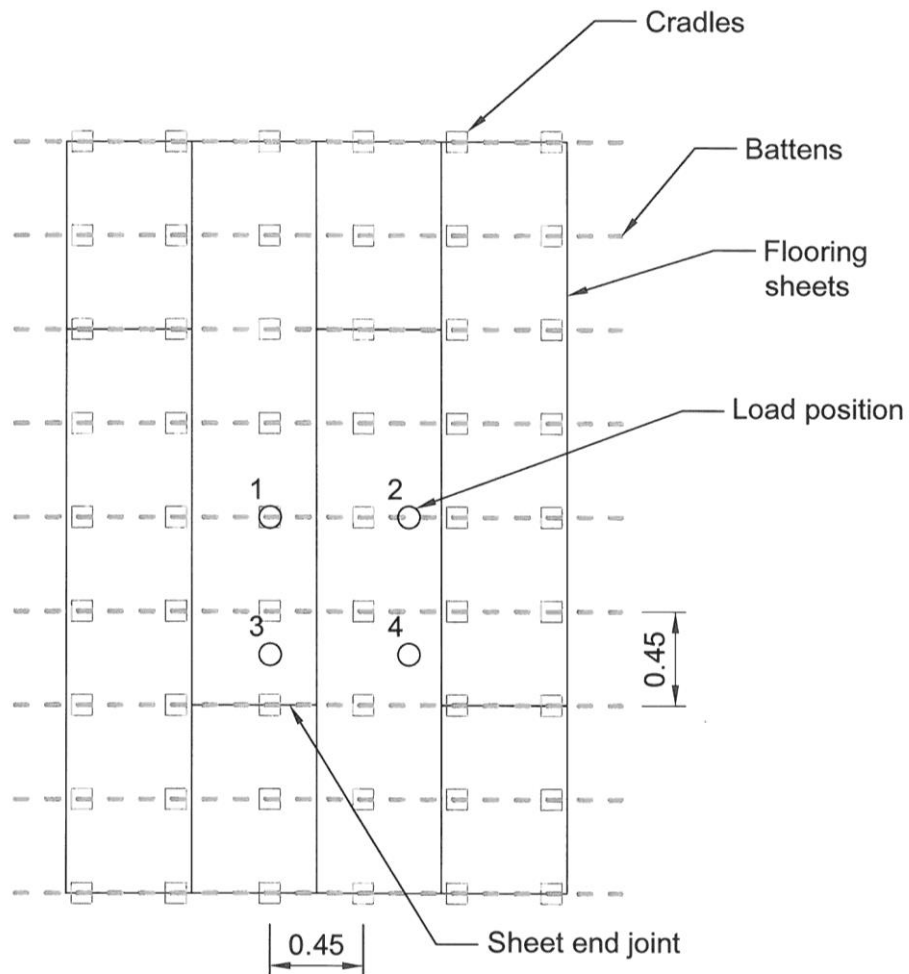
A 3.6 m x 2.4 m section of the flooring system was constructed by the client on the floor of the BRANZ Structural Laboratory. Details are shown in Figure 1.

Figure 1 Test specimen set up

Battens were finger jointed Radiata Pine 42 x 42 mm and were not attached to the cradles which were laid directly on the concrete floor. Flooring was James Hardie Scyon Secura sheets, 19 mm thick and 600 mm wide, with long edges machined into a tongue and groove profile. They were cut to length as required to form an offset pattern, and fixed to the battens with 8g screws. Screw spacing was 50 mm from the long edges and 167 mm centres along the batten. The specimen ready for testing is shown in Photograph 2.

1. Over batten and cradle
2. Over batten between cradles
3. Between battens on cradle lines adjacent sheet butt joint
4. Between battens and cradles.

The locations are shown in Figure 1.

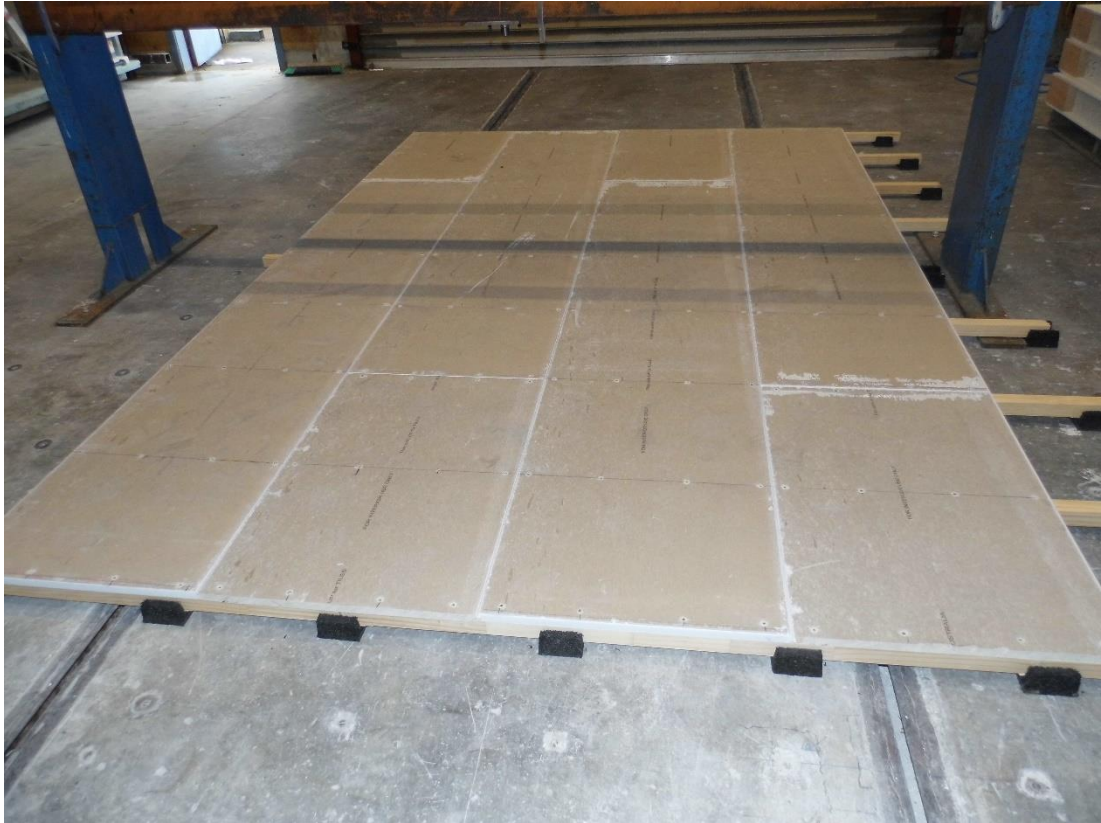
Photograph 2. Specimen ready for test

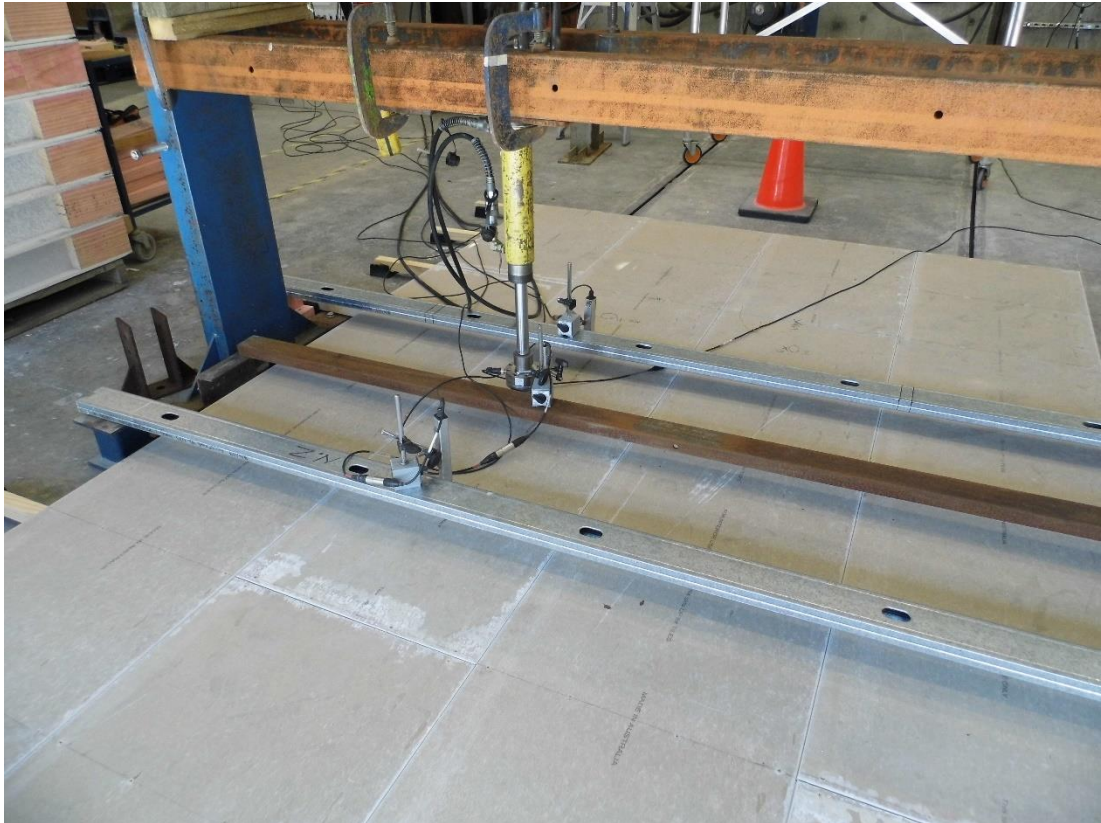
Beams supporting deflection gauges were placed across the specimen at the load point and over adjacent battens. The test set up is shown in Photograph 3.

Photograph 3. Test set up

The specimen was set up on the lab floor as described above. A loading gantry was constructed over it and bolted to the lab floor. A hand pumped hydraulic jack was installed on the loading beam together with a 10 kN load cell and a 100 mm diameter loading applicator. AS/NZS 1170.1 states that the concentrated load should be applied over an area of not greater than 0.01 m², which equates to a diameter of 113 mm. The locations of the load application were:

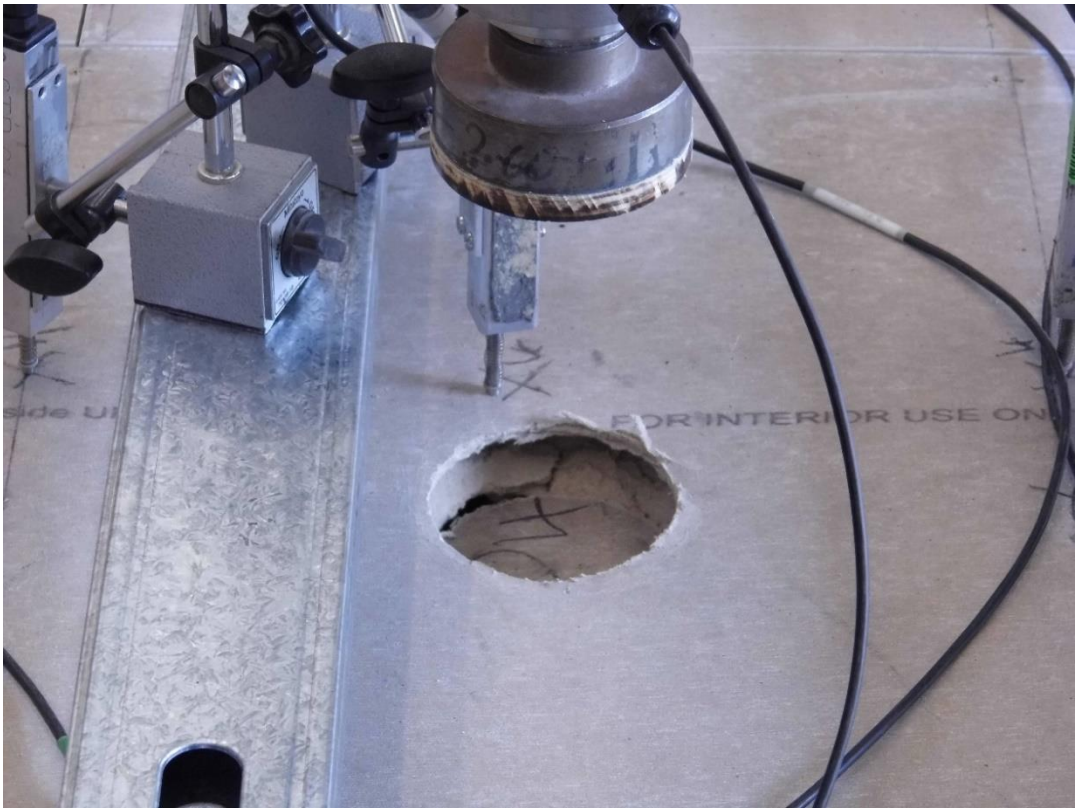
Photograph 4. Punch failure in Test 4

Dishing of the flooring around the load application point could quite clearly be seen, and at greater deflections, the joints between the flooring sheets were clearly distorted. Deflections were largely recovered on removal of load, indicating that no inelastic action or permanent effects had occurred. At the end of Test 4 the load applicator punched through the flooring sheet, as shown in Photograph 4. This happened at a load of 10 kN, well above the AS/NZS 1170.1 loading criteria. For “General Office” occupancy the concentrated load criteria is 2.7 kN, and for “Shop floor or retail” occupancy it is 3.6 kN.

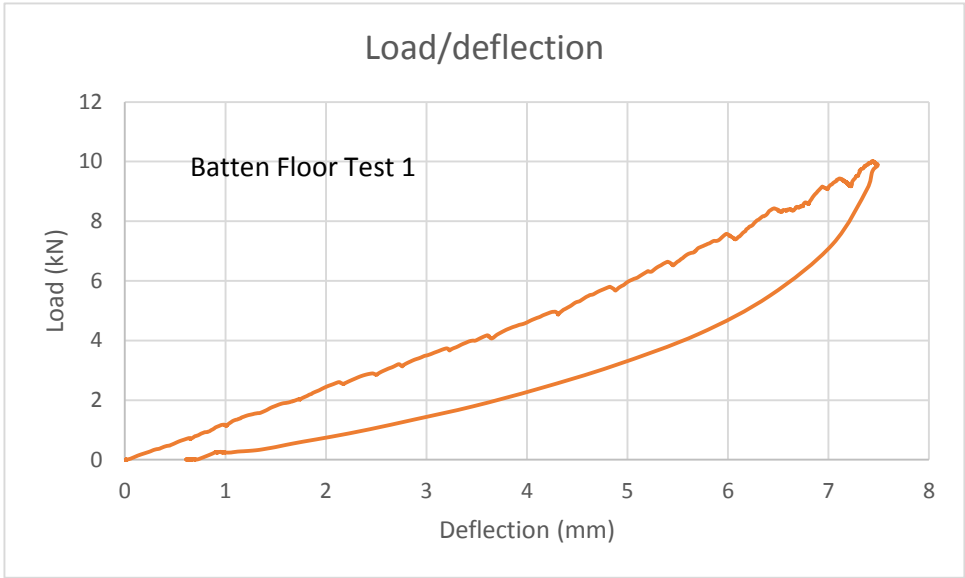
Figure 2. Load/deflection plot, test 1

Plots of load/deflection as recorded are presented in Figures 2 to 5, and a summary is shown in Table 1. Note that “absolute deflection” is the deflection measured relative to the concrete laboratory floor, and “relative deflection” is the deflection of the load point relative to the flooring sheets over the adjacent battens.

Test	2.7kN (General Office)		3.6kN (Retail)	
	Absolute	Relative	Absolute	Relative
1	2.7	2.3	3.7	3.1
2	2.6	2.1	3.8	3.0
3	3.4	1.9	4.8	2.7
4	3.7	2.1	5.4	3.1

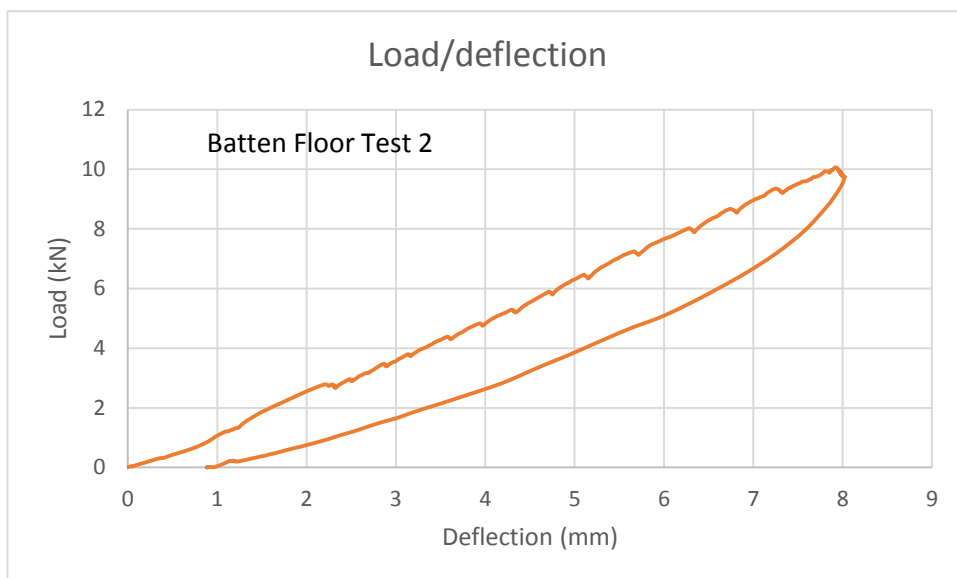
Figure 3. Load/deflection plot, test 2

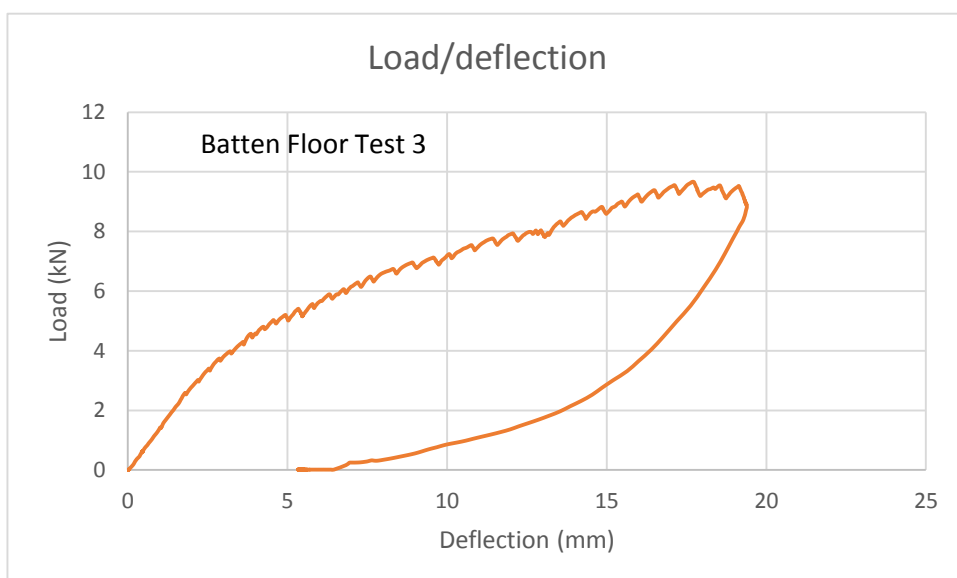
Figure 4. Load/deflection plot, test 3

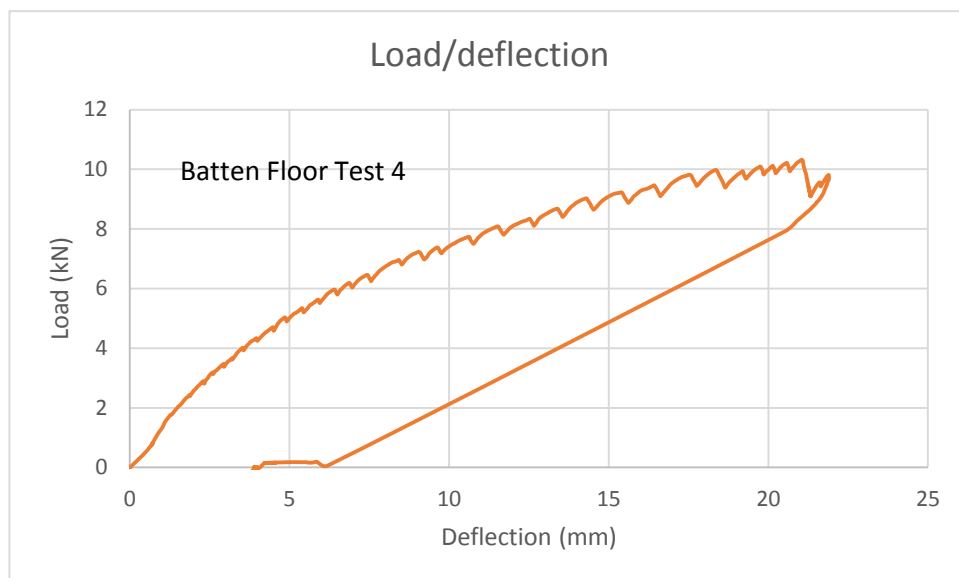
Figure 5. Load/deflection plot, test 4
